CONSIDERATION OF STEAM GENERATOR TUBING INTEGRITY

Xaver Schuler¹, Steffen Riehm², Bernd Gruhne³, Jan Köhler⁴

¹ Head of Dep. QA Mech. Comp. EnBW Kernkraft GmbH, Neckarwestheim (x.schuler@kk.enbw.com)

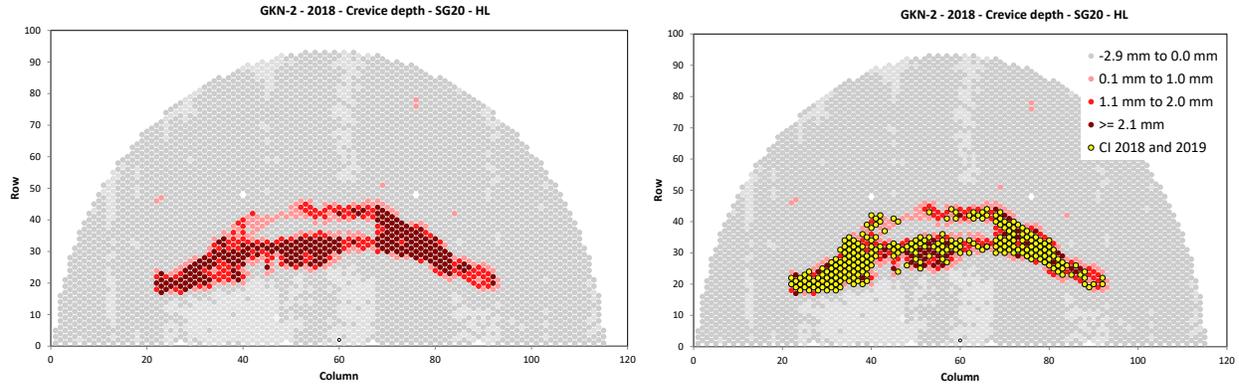
The scope of eddy current testing (ECT) and the number of SG tubes with CI and VI detected during the outages 2017 to 2021 are summarized in Table 1. Most of the CI findings were located in SG20 on the hot leg (HL) side at or near by the upper transition of the upper roll expansion in areas with crevice corrosion of the ferritic tube sheet (TS), Figure 1. In the outage 2019 and the following, in addition to the X-Probe, the MRPC-Probe was used in areas with possible crevice corrosion to get more detailed information about size and distribution of the findings. This results in an additional number of detectable indications. The review of the 2018 X-Probe data revealed that a large number of CI detected in 2019 already did exist in 2018. The largest indications are multiple CI (MCI) distributed on the circumference of the SG tubes with a maximum local flaw depth of about 90% of the wall thickness (WT), Figure 2. Figure 3 shows the flaw characteristic of the two largest indications detected in the 2018 outage.

Figure 1: Location of CI in SG20 (right) related to crevice corrosion (crevice depth > 0) (left)

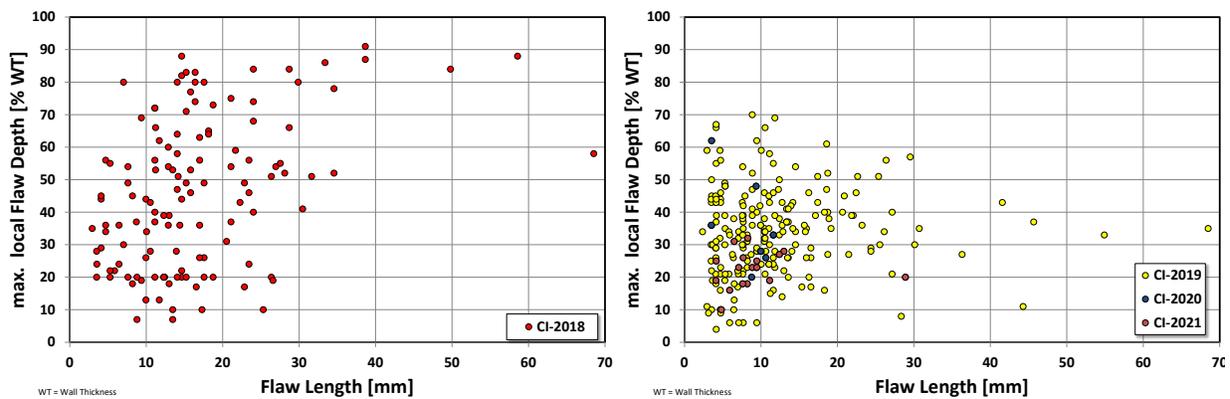
Figure 2: Size of CI detected in 2018 (left) and the following outages 2019, 2020 and 2021 (right)

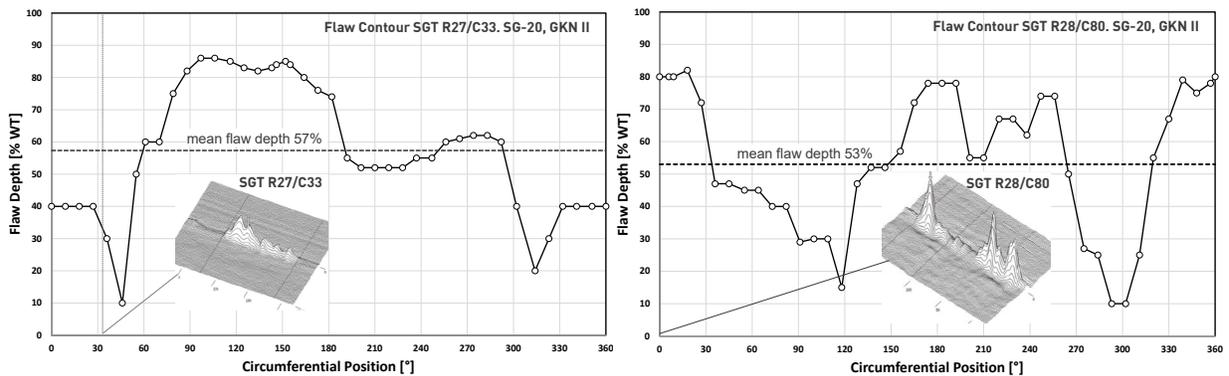
Figure 3: C-Scan and flaw contour determined by use of the amplitude signal of the MRPC-Probe

In a first approach, the limit load of SG tubes with circumferential flaws of constant depth was determined based on simplified and conservative fracture mechanics (FM) calculations using the FSK/MPA- and R6-Method. For the covering ATWS load case, the maximum calculated critical flaw depth using the FSK/MPA method was 80% WT, Figure 7 (left). For this flaw depth the R6-Method calculated a maximum differential pressure of $\Delta p=17.5$ MPa, Figure 7 (right), that is above the value of 15.5 MPa for the ATWS load case. This shows a large safety margin compared to the mean flaw depth of 57% WT of the largest finding, see Figure 3 (left).

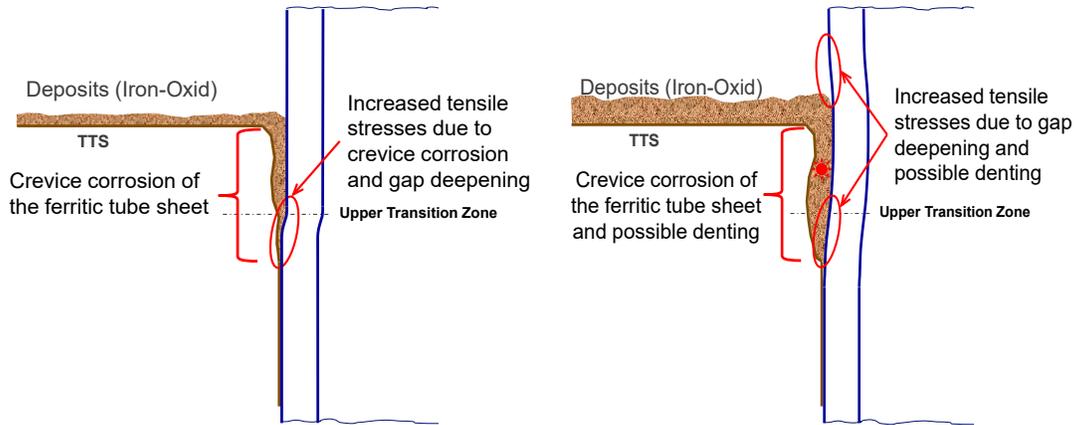
The detailed root cause analysis performed in 2018 outage revealed the following degradation mechanisms. Outer Diameter Stress Corrosion Cracking (ODSCC) caused the crack-like circumferential linear indications (CI) at the upper transition of the upper roll expansion. The axial tensile stresses at this location are increased because of the crevice corrosion of the ferritic

TS and deepening of the crevices, Figure 4. Denting was detected at several SG tubes on the CL-side but at the HL-side, denting seems to be of minor importance. Pitting respectively inter granular attack (IGA) caused the pit-like volumetric indications (VI).

Figure 4: Zones of crevice corrosion and increased axial stresses without (left) and with denting (right)

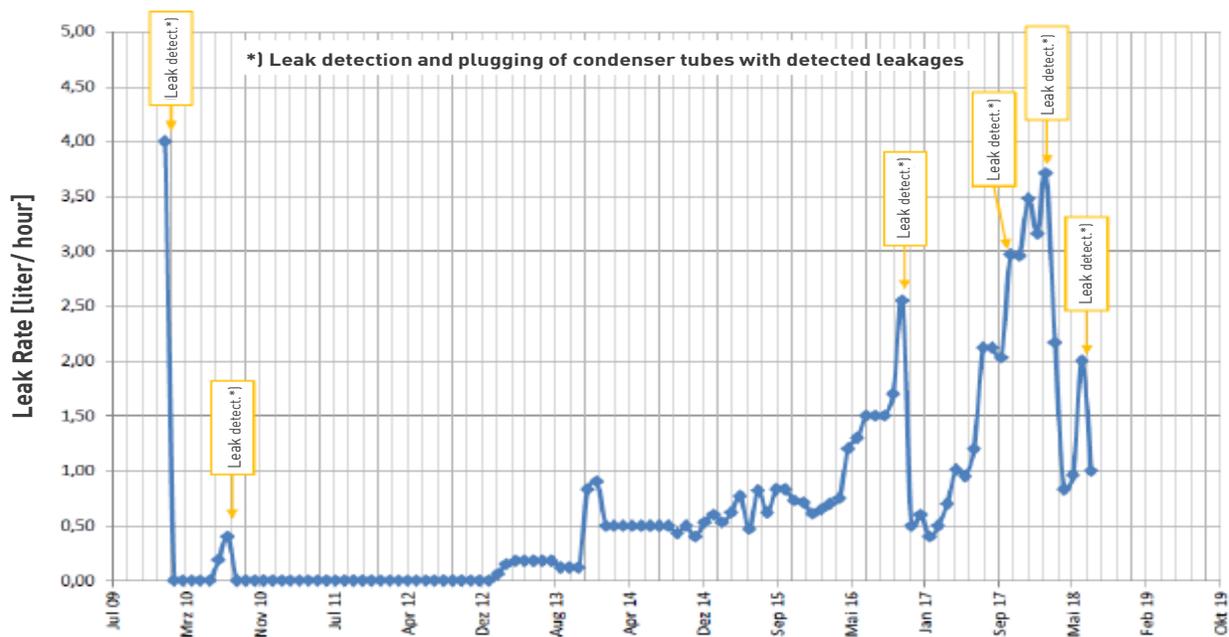
The main root cause for these corrosion mechanisms was the increasing sulphate concentration in the feed water because of small, but persistent condenser leakages during the years 2013 to 2018, Figure 5. However, these leaks and the resulting ingress of sulphate in the feed water were still within the permissible limits of the VGB Standard (2006). Never the less, the enrichment of these sulphate impurities in the iron oxide deposits on the Top of the Tube Sheet (TTS) and SG tube surfaces caused the observed findings.

The cause of the condenser leakages was identified as droplet impact erosion. Hence, the leak detection was very difficult because of the very tiny leaks caused by this mechanism and the adverse conditions for leakage tests in the large four-flow exhaust section.

Figure 5: Persistent condenser leakages during the years 2013 to 2018

The most important remedial measure was to prevent further condenser leakages. After identifying the degradation mechanism “droplet impact erosion”, it was possible to identify the most affected condenser tubes for preventive plugging, Figure 11 (left). After preventive plugging of more than 2,000 condenser tubes, no further condenser leakages occurred.

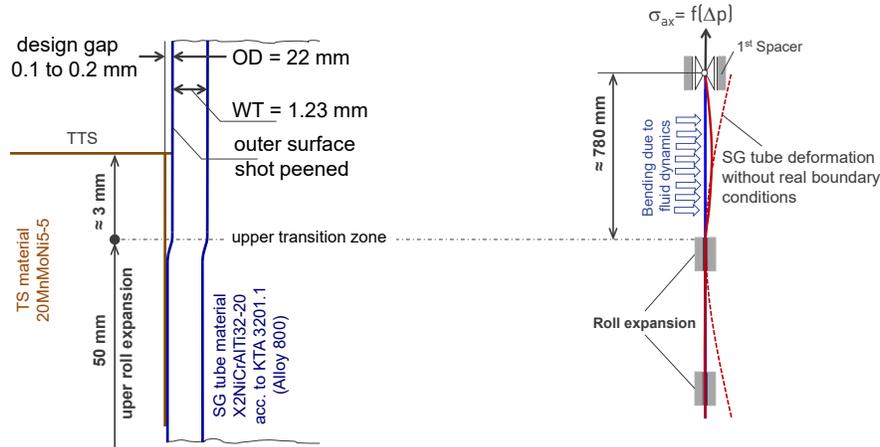
Figure 6: Relevant dimensions in the zone of findings (left) and boundary conditions (right)

The relevant load cases and related loads are listed in Table 2. Regarding the stresses near the tube sheet, the covering load case in GKN II for postulated emergency and faulted conditions (Level C and D) is the ATWS load case. In addition to the differential pressure between primary and secondary side, the fluid dynamic loading of the SG tubes between TS and first support grid was considered by the application of a global bending moment of 9.1 Nm conservatively. For the relevant dimensions and boundary conditions, see Figure 6.

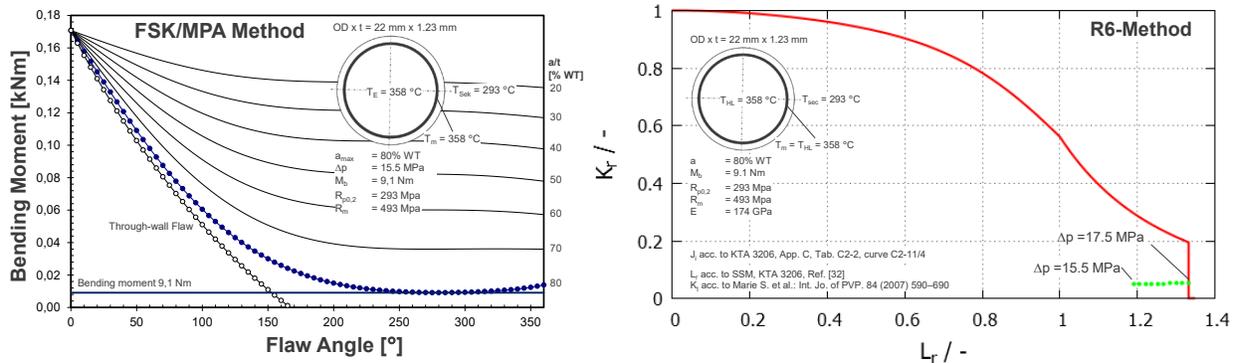
Figure 7: Result of fracture mechanics calculations with FSK/MPA- (left) and R6-Method (right)

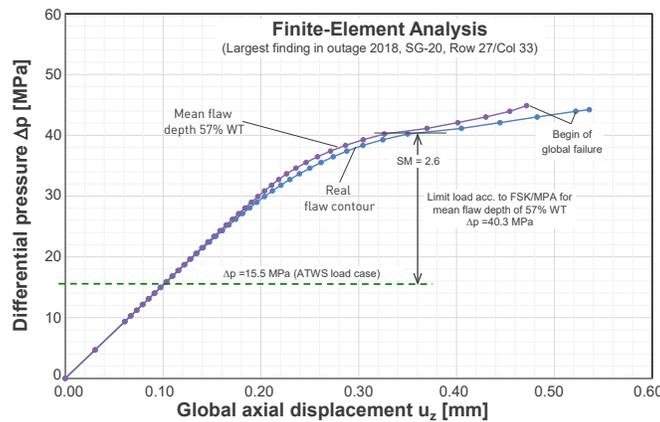
In addition to these calculations, finite element (FE) analyses were performed, considering the real flaw contour and realistic boundary conditions, Figure 6 (right), as well as elastic-plastic material behavior based on lower bound stress-strain curves. For the largest finding, Figure 3 (left), the calculated failure pressure Δp (plastic limit load) was 44 MPa, Figure 8, which is a safety margin (SM) of $SM=2.8$ compared to the ATWS load case. The FE-analysis based on the mean value of the flaw depth of 57% WT shows nearly the identical load-bearing curve and failure pressure. These calculations also confirm the conservatism of the MPA/FSK calculation based on the mean value of the flaw depth ($SM=2.6$, see Figure 8).

Figure 8: Load bearing behavior determined by elastic-plastic FE-analyses

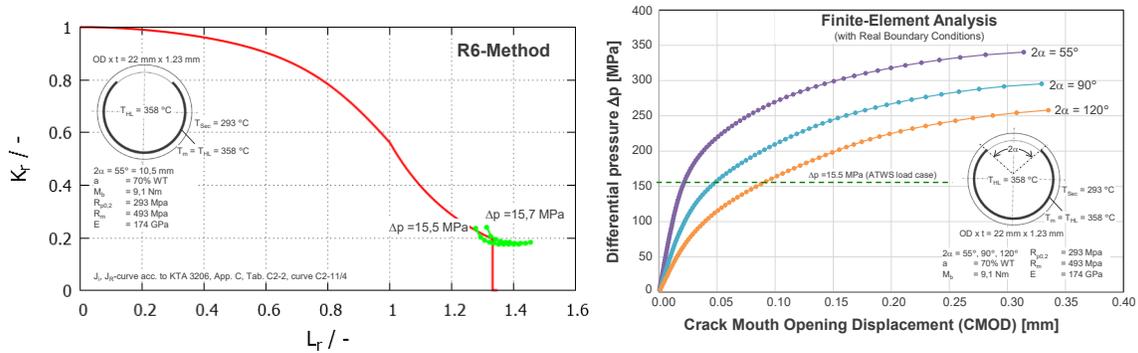
on SG tubes with ODS/CC findings and especially of Siemens/KWU SGs. Based on this evaluation a conservative estimation on the flaw evolution until the next inspection (= next outage) were made. The flaw growth was postulated up to 70% of WT constant over the full circumference. Additionally, within the framework of the LBB-assessment, a local through-wall flaw up to the critical flaw length was assumed. For this flaw configuration, the calculated critical through-wall flaw length was 10.5 mm (flaw angle $2\alpha_{LBB} = 55^\circ$) by use of the FSK/MPA- and R6-method respectively, Figure 9 (left). In comparison with the FE analysis, taking into account the real boundary conditions of the SG tubes, the great conservatism of the simplified FM calculations becomes apparent. For the maximum emergency and faulted conditions (ATWS load case), flaw angles up to $2\alpha = 120^\circ$ are still stable, Figure 9 (right).

Figure 9: LBB-Assessment: Calculation of critical through-wall flaws length

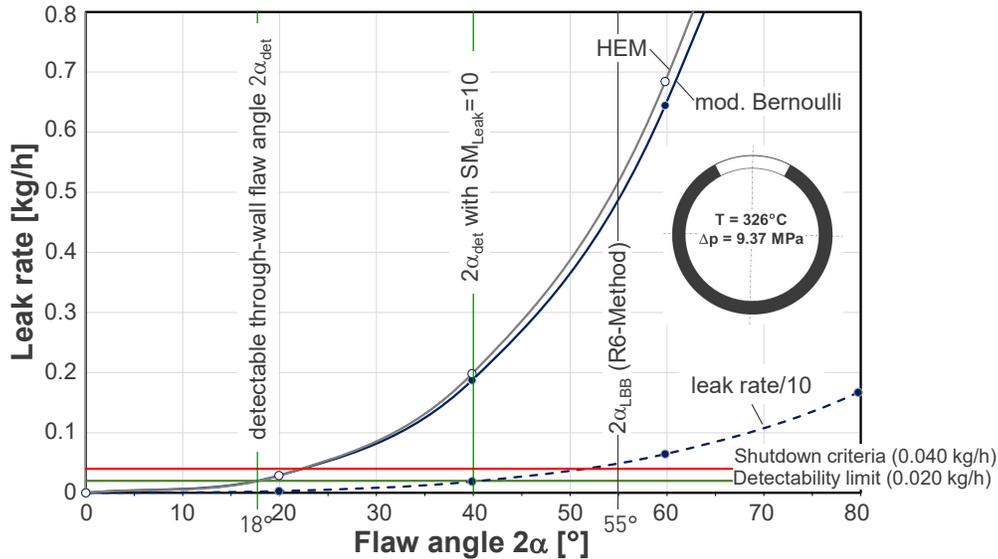
For the LBB-assessment, the calculation of the leak rate as a function of flaw length for normal operating conditions is necessary. This calculation was performed using the leak rate models “modified Bernoulli” and “homogenous equilibrium model (HEM)” acc. to KTA 3206 (2014), App. B 3.2.2.2 and B 3.2.2.3 respectively. The leak opening area was calculated using linear-elastic material behaviour and the postulated circumferential flaw depth of 70% WT was not taken into account. This is conservative related to leak rate detectability. Figure 10 shows the results of these calculations in comparison with the detectability limit (0.02 kg/h) and shut down criteria (0.04 kg/h). Even for the shortest calculated critical through-wall flaw size of $2\alpha_{LBB} = 55^\circ$, see Figure 9 (left), the safety margin with respect to LBB is greater than a safety margin of

$SM_{Leak}=10$. This LBB-assessment demonstrates large safety margins with respect to the SG tube integrity for the subsequent operation period.

Figure 10: LBB-Assessment

criteria of 0.04 kg/h, as defined in the operating rules of GKN II, fulfils the RSK recommendation and includes a large safety margin with respect to LBB, see Figure 10.

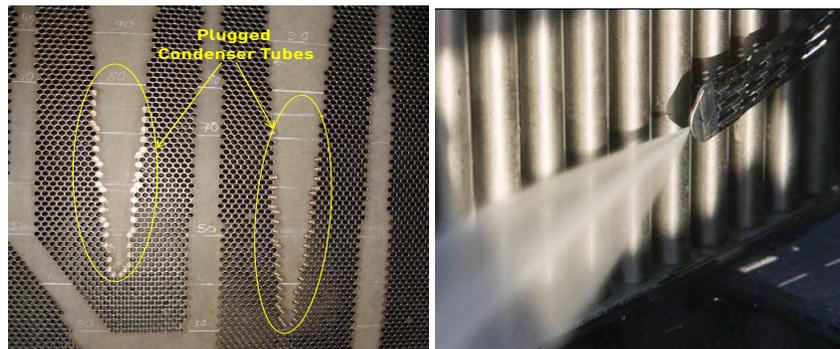
Figure 11: Preventive plugging of condenser tubes (left), mechanical SG TTS-cleaning (right)

The second important measure was the mechanical TTS cleaning in the outage of 2018 to remove the soft sludge with most of the sulphate inventory of the SGs, Figure 11 (right).

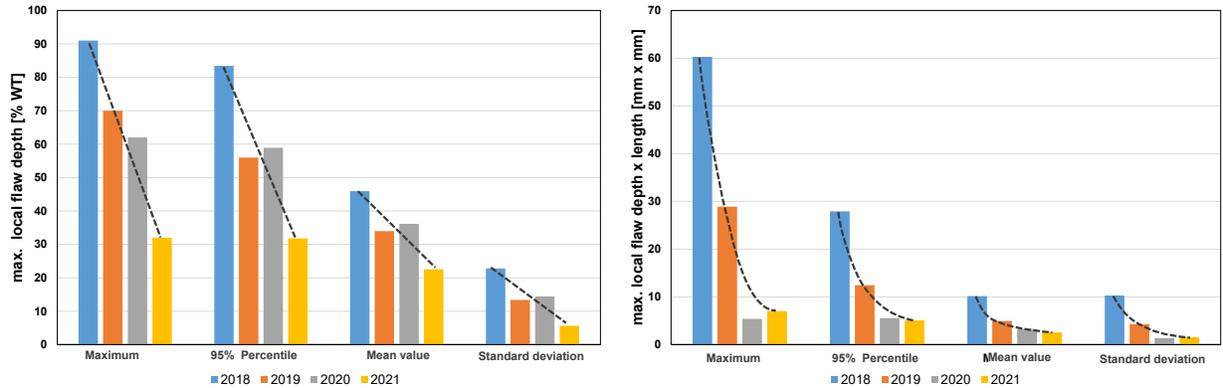
The statistical evaluation of the findings confirms the efficiency of the implemented measures, Figure 12.

Figure 12: Statistical evaluation of maximum local flaw depth (left) and flaw size (right)

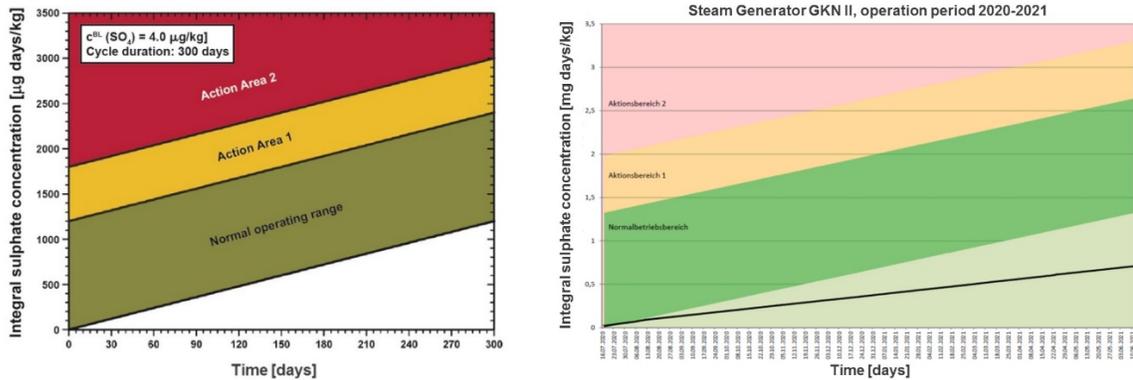
As a consequence of the GKN II SG experience, the VGB guideline for the water chemistry of LWR Plants was revised. The most important modification was the implementation of integral control parameters for the surveillance of longer ingress periods of even small amounts of ionic impurities, see e.g. for sulphate ingress Figure 13 (left). Since the preventive plugging of condenser tubes and the cleaning and flushing measures, all control parameter of the secondary water chemistry are within and mostly below the normal operating range, see e.g. sulphate concentration Figure 13 (right).

Figure 13: Integral control parameter for sulphate ingress acc. to VGB Standard (2020) (left) and GKN II SG data for the operation period 2020-2021 (right)
