RELIABILITY CONSIDERATIONS FOR ULTRASONIC TESTING AT CRACK FIELDS IN LARGE FORGINGS

Anne Juengert¹, Oliver Jacobs², Ludwig Stumpfrock³, Stefan Weihe⁴

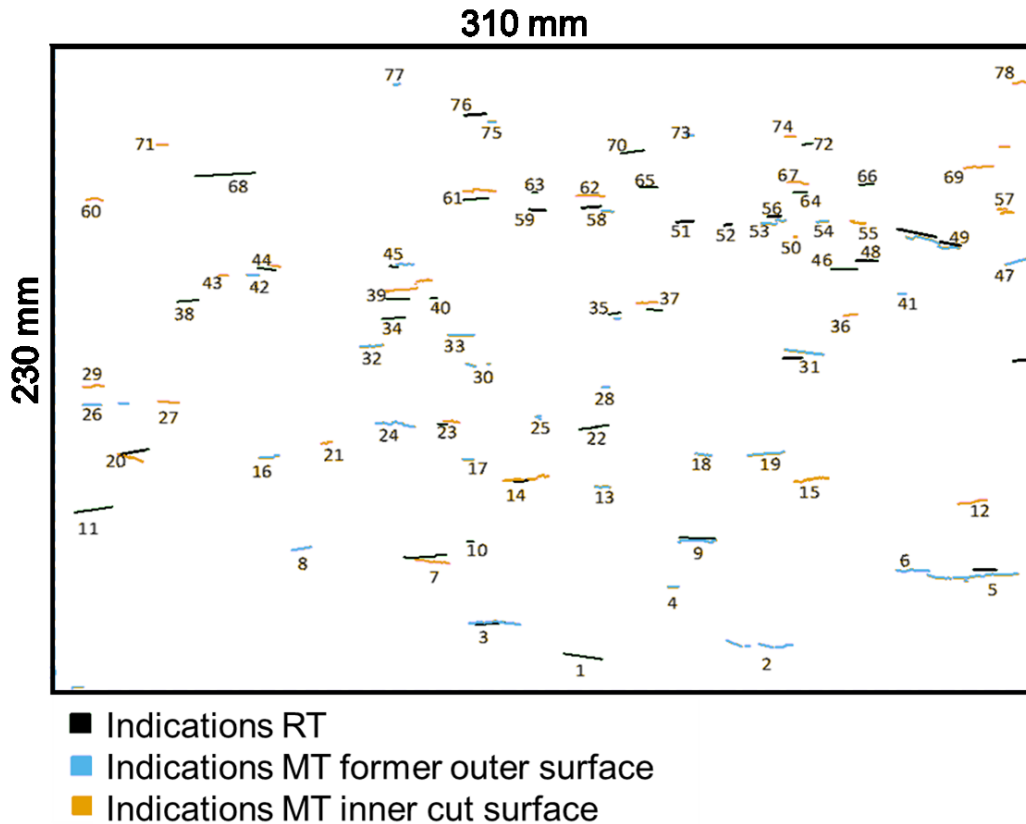
Figure 3: Indications detected with MT (blue, orange) and RT (black) at the plate ABC cut from the test block TK1

The MT indication lengths are measured by the visible size at the surface. The RT indications lengths are measured in the digital images. The sizing results of MT and RT may differ for the same indications, as each testing technique has physical limits. For the verification the maximum of both indications lengths was taken.

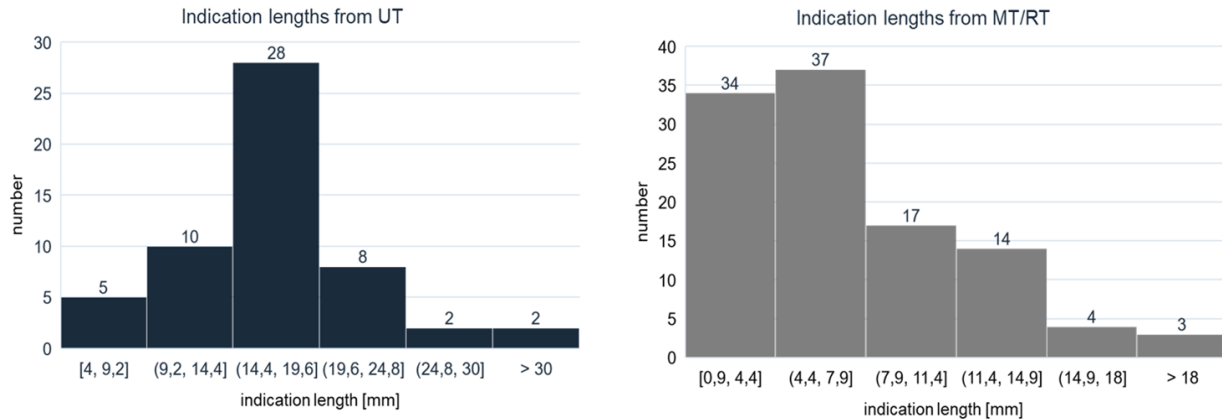
Figure 4: Distribution of indication sizes with UT (left) and MT/RT (right)

The sizes of the indications detected at TK1 are estimated using the 6dB drop. The distribution of indication lengths is shown in Figure 4. The mean indication length of all detected indications was estimated to 17 mm.

It turned out, that the mean indication length of the MT and RT testing was estimated to only 7 mm. As these indications are caused by the same flaws like the UT indications, it is clearly visible, that the UT indications are overestimated. However, the test blocks were big even compared to large components like RPV and sound paths between 150 mm and 600 mm were necessary to reach the cracks. Sound beam

divergence for these sound paths cannot be neglected and is the main cause of the overestimation of the flaws.

Due to the cutting of the test block, a verification of the indication lengths was possible by MT and RT testing. Each MT or RT indication was linked to an UT indication if possible. It can be seen from the overall number of indications detected with UT compared to MT/RT, that not all flaws could be detected with UT. This is caused by shadowing of indications that lie deeper in the crack field.

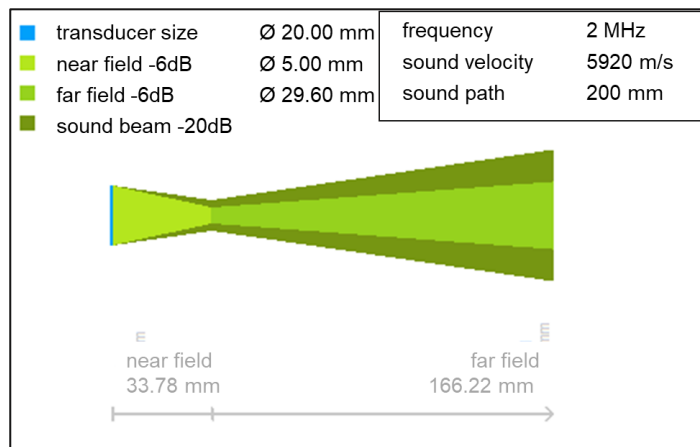
Figure 5: Sound beam of an ultrasonic normal probe with 20 mm diameter and 2 MHz for a sound path of 200 mm

Test block TK2 was used in the following to perform sound field optimization. Due to a different microstructure the attenuation in the test block was higher compared to the test block TK1 and transducers with a center frequency of 2 MHz had to be used. As can be seen in Figure 5 the focus of the sound beam for the used single element transducer lies in 34 mm depth. The main part of the crack field in TK2 is located deeper than 120 mm in the test block, thus sound beam divergence plays a major role.
