THREE-DIMENSIONAL STRUCTURAL ANALYSIS FOR ENHANCING RESILIENCE OF NEXT-GENERATION NUCLEAR STRUCTURES UNDER EXTREMELY HIGH TEMPERATURE CONDITIONS

Satoshi Futagami¹, Masanori Ando², and Hidemasa Yamano³

¹ Manager, Japan Atomic Energy Agency, Oarai, Ibaraki, Japan (futagami.satoshi@jaea.go.jp)

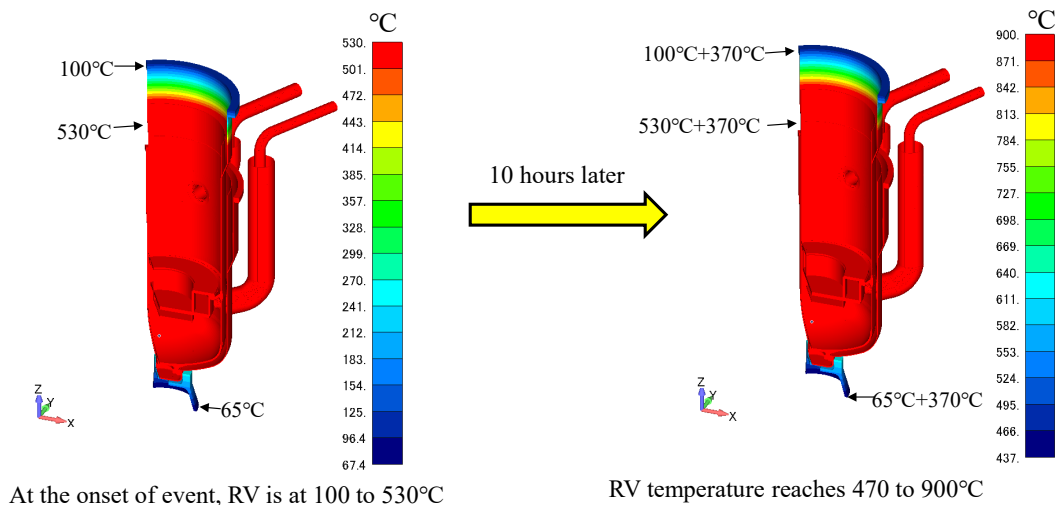
- Pipe failure causes loss of all cooling functions and results in PLOHS.
- The RV body temperature continues to rise for 10 hours from 530 °C to 900 °C (initial temperature + 370 °C). Temperature gradient is not changed since the occurrence of the event (see figure 2). Since then, 900 °C is kept till 24 hours for this calculation.
- The GV temperature is the same as the RV body temperature.
- Internal pressure of the primary system is constant assuming the piping failure (pressure difference between the inside and the outside of RV is 0).

Figure 2. Temperature distribution condition

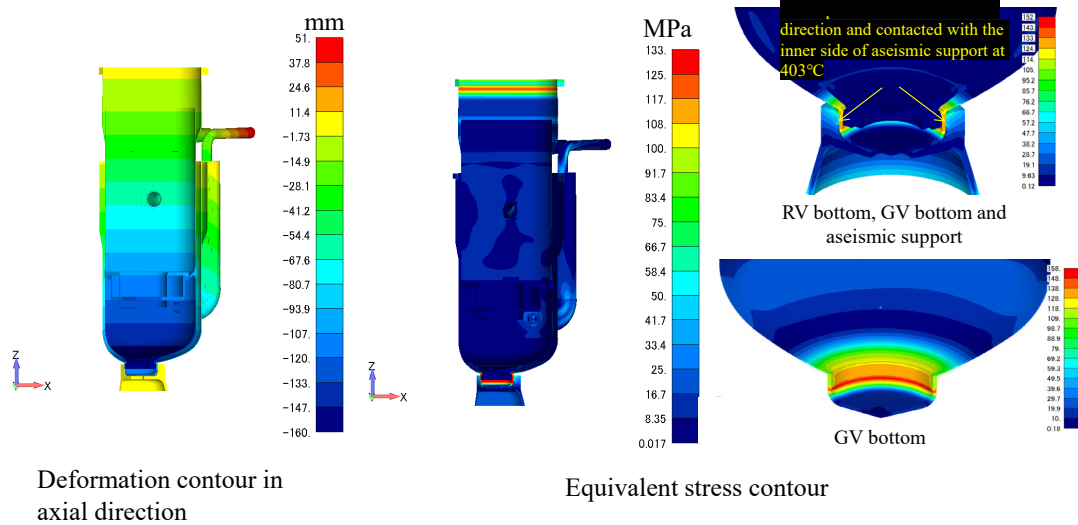
Figure 3. Analysis results at 530 °C (Case 1)

Figure 3 shows the analysis results of initial condition at 530 °C. GV expanded in circumferential direction and contacted with the inner side of aseismic support at 403 °C.

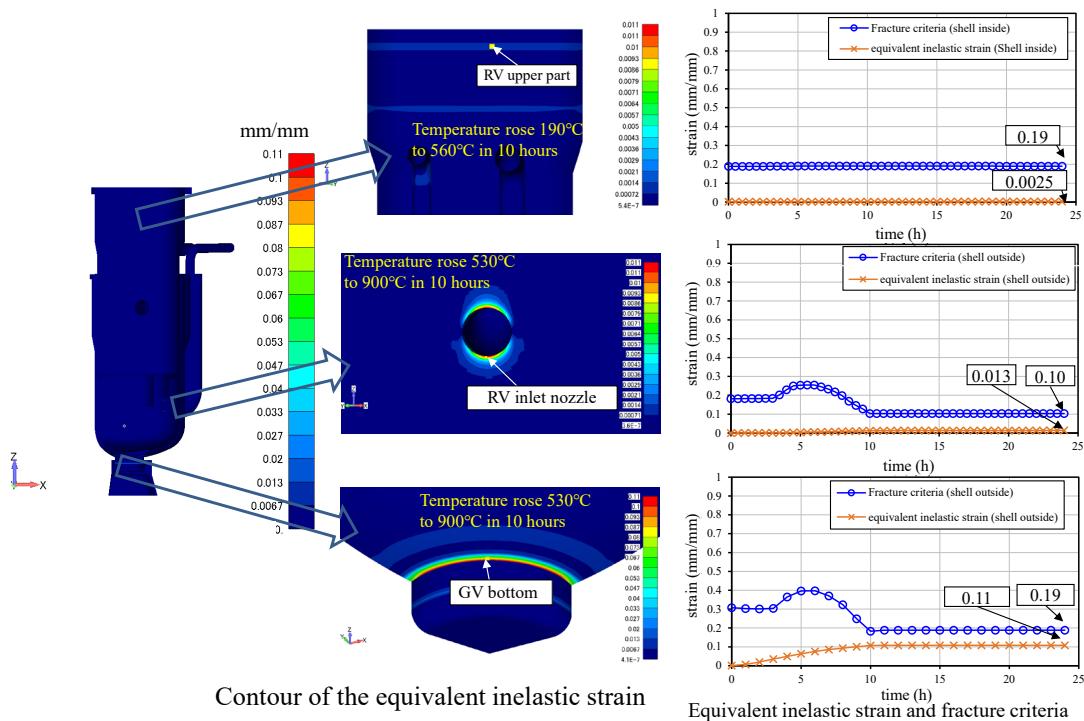
Figure 6 shows structural integrity analysis based on equivalent inelastic strain (plastic and creep strain) of Case 1. From the analysis results, the upper part of the RV body, the inlet nozzle area, and the GV lower part were identified as the areas that developed relatively great equivalent inelastic strain (plastic and creep strain). These correspond to the areas on which should be focused for damage prevention against extremely high temperatures. These areas were identified, but the integrity evaluation using the fracture criteria showed that the equivalent inelastic strains (plastic and creep strain) at the identified areas did not exceed the fracture criteria nevertheless. It means these areas would not develop ductile fracture within a temperature of up to 900 °C and in the calculation time 24 hours. On the other hand, RV, GV and aseismic support contacted with each other on the bottom. And, great stress and relatively high equivalent anelastic strain were generated on the GV bottom. This result suggests that no discontinuous section of the RV and the GV bottom is recommended to avoid the fracture of RV and GV bottom in order to enhance the resilience.

Figure 6. Structural integrity analysis based on equivalent anelastic strain of Case 1

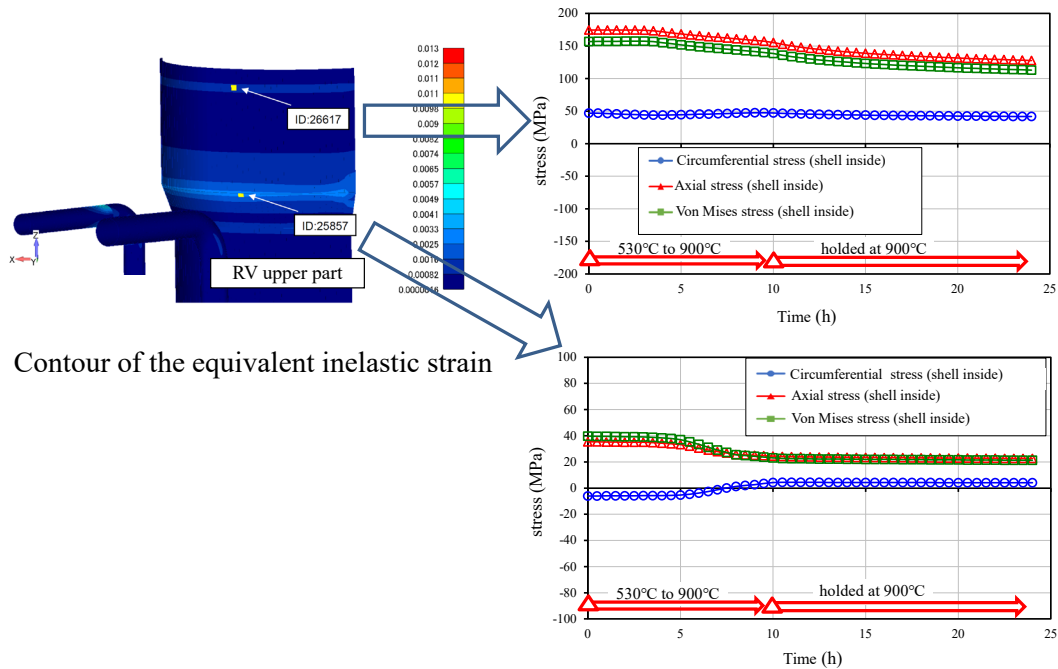
Figure 7 shows the analysis results of stress on the RV upper part of Case 1. Left side of this figure shows contour of the equivalent inelastic strain (plastic and creep strain). Relatively high equivalent inelastic strain (plastic and creep strain) area is pointed to discuss stress history (ID:26617 and ID:25857). Stress on the RV upper part which was initially high at a low temperature (ID:26617) remained high, whereas stress on the RV upper part which was initially high at a high temperature (ID:25857) was relaxed by creep behavior as the temperature rose.

Figure 7. Stress on RV upper part of Case 1

These stress histories were pretty much the same as Case 2 (without aseismic support). These results mean that deformation and contact behavior at the RV and the GV bottom area did not influence to the fracture of the RV.
