*Transactions, SMiRT-26*  
Berlin/Potsdam, Germany, July 10-15, 2022  
Special Session - Steam generator tube integrity

## **SPECIMEN TESTING FOR STEAM GENERATOR TUBE LEAKS WITH MEASUREMENT OF FLOW PATTERNS**

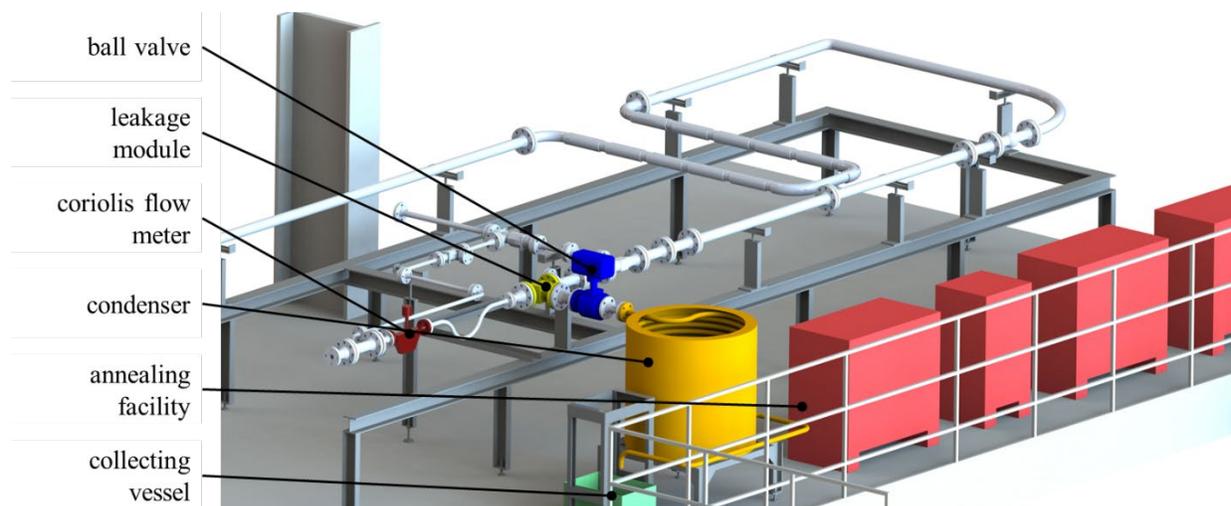
The testing has been done at the FSI (Fluid-Structure-Interaction) test rig at MPA University of Stuttgart, which was built up as a modular test stand for component testing under fatigue loading in hot and cold water cycling environmental condition and upgraded for also allowing leak rate testing in a previous project (Silber et al., 2017). A detailed description of the FSI test rig at MPA University of Stuttgart is given by Schmid et al., 2021. Due to the requirements concerning the investigations that were planned for this project, some major adaptations had to be realised at the test rig. This section explains the different setups of the FSI test rig that were realised in order to meet the requirements for the investigations. The leak rate test configuration allows for measurement of leak rates using Coriolis-flow meters and a leakage collecting vessel for up to 200 g/s as well as measurement of pressure up to 75 bar and temperature in the stagnation volume up to 270 °C. In Figure 1 the experimental setup is shown.

Figure 1. FSI test rig configuration for leak rate investigations

The experimental setup used for the leak rate measurement investigations is shown in Figure 1. Leak rate measurements were carried out in the temperature range from 20 °C to 270 °C for pressures between 5 and 80 bar. The leak mass flow was guided into the condenser, which approximately corresponds to free discharge in air environment.

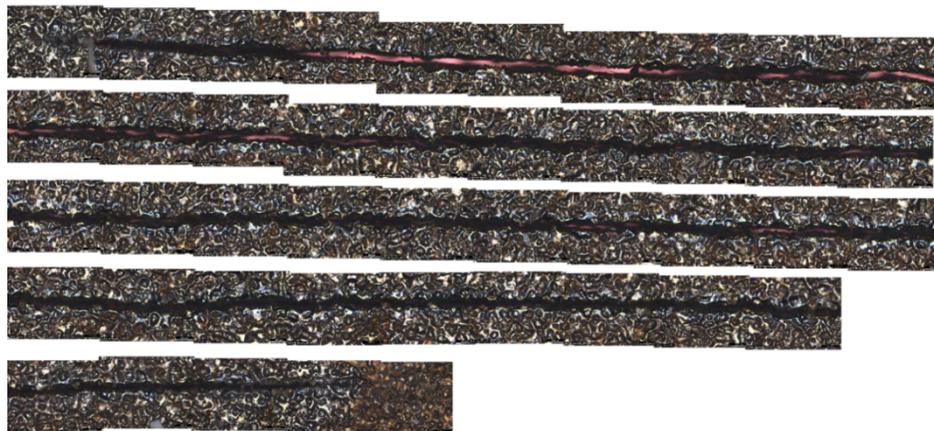
Figure 6. Stitched images of the fatigue crack of R4 from the outlet side after leak rate measurement with a full crack length of around 44 mm
